Pacifica Lighthouse Hotel Repair Project

2019

Engineer Building Inspection Report

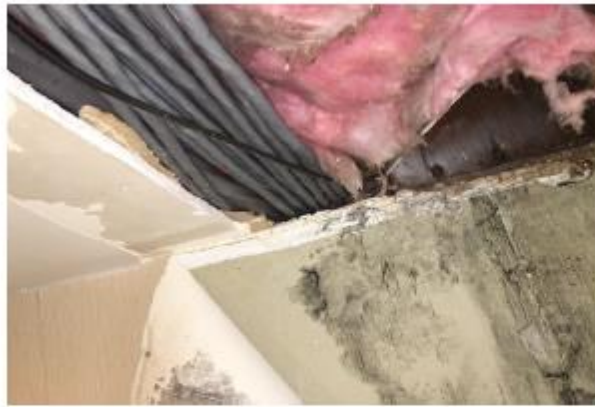
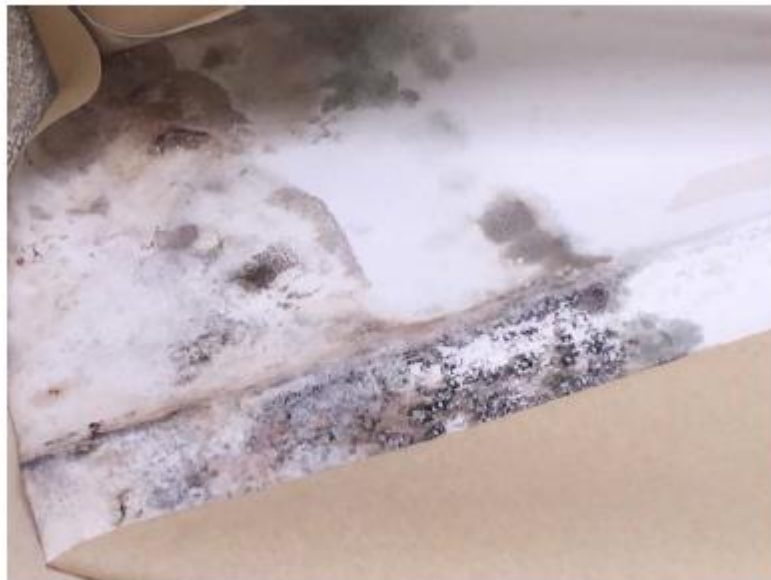
Biological growth due to water infiltration

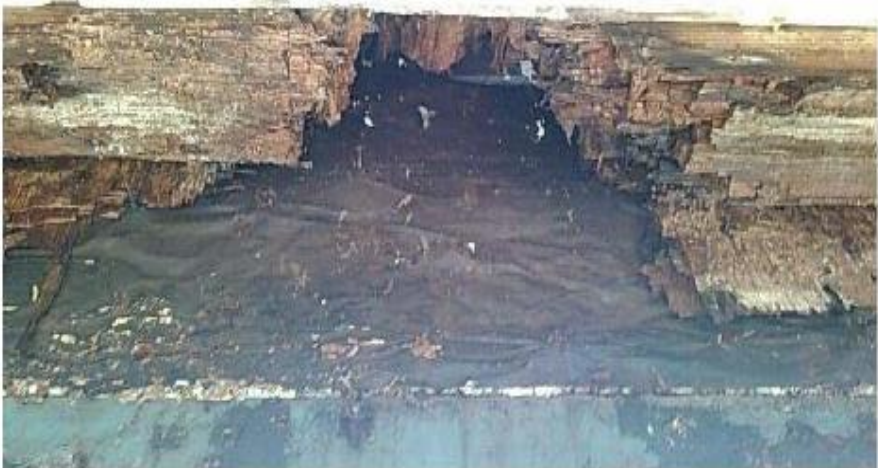
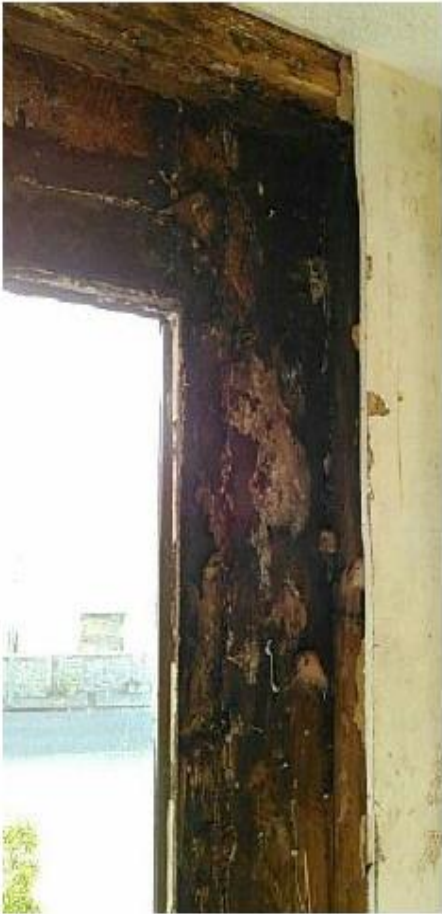
Decay of structural members

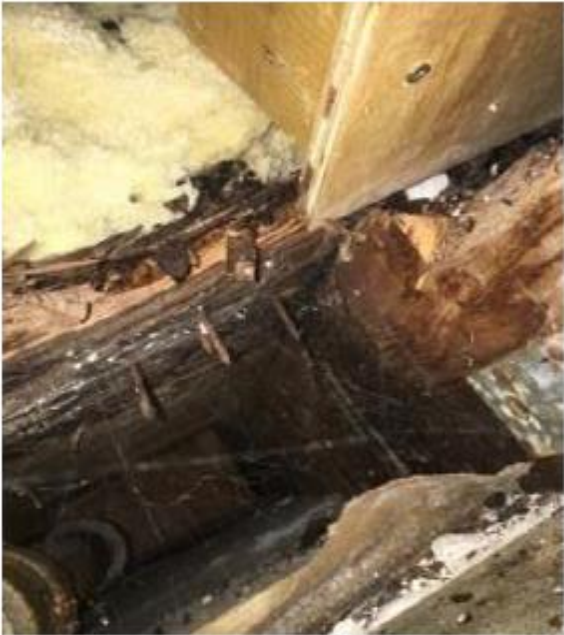
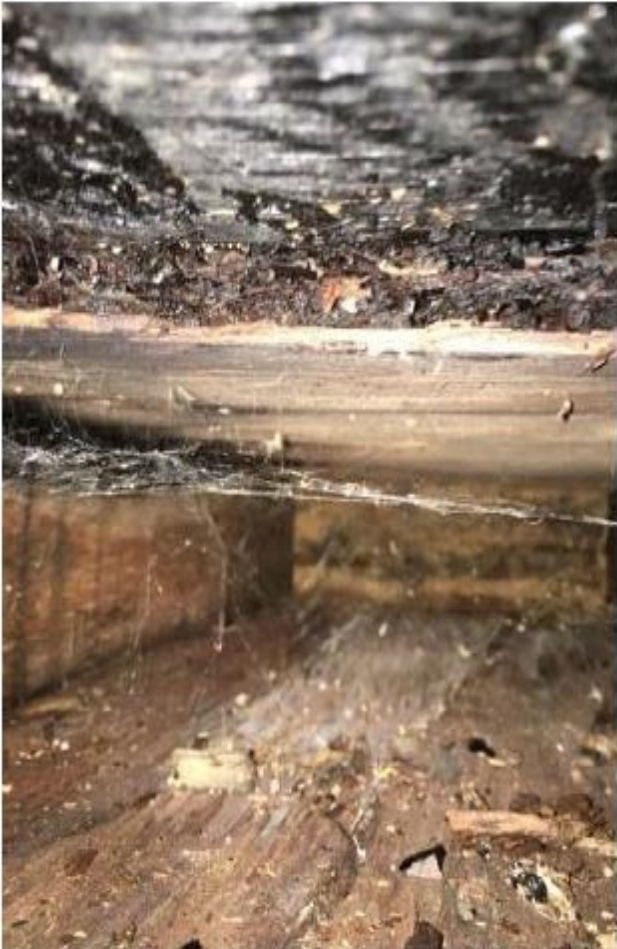
- o Interior walls are not generally affected except for those locations where wall is adjacent to area of highwater infiltration near the exterior walls, typically at demising walls between rooms and particularly below the corners of the building where lower level roof areas meet exterior walls. We found evidence of failed waterproofing membranes.
- o Exterior walls have severely been impacted by decay most of the exterior plywood presents evidence of deterioration due to water damage. The supporting studs for the exterior walls have approximately 35% of the exterior side damaged. They still provide adequate support for vertical loads but their capacity for lateral loads has been impaired.

Decay at Interior walls

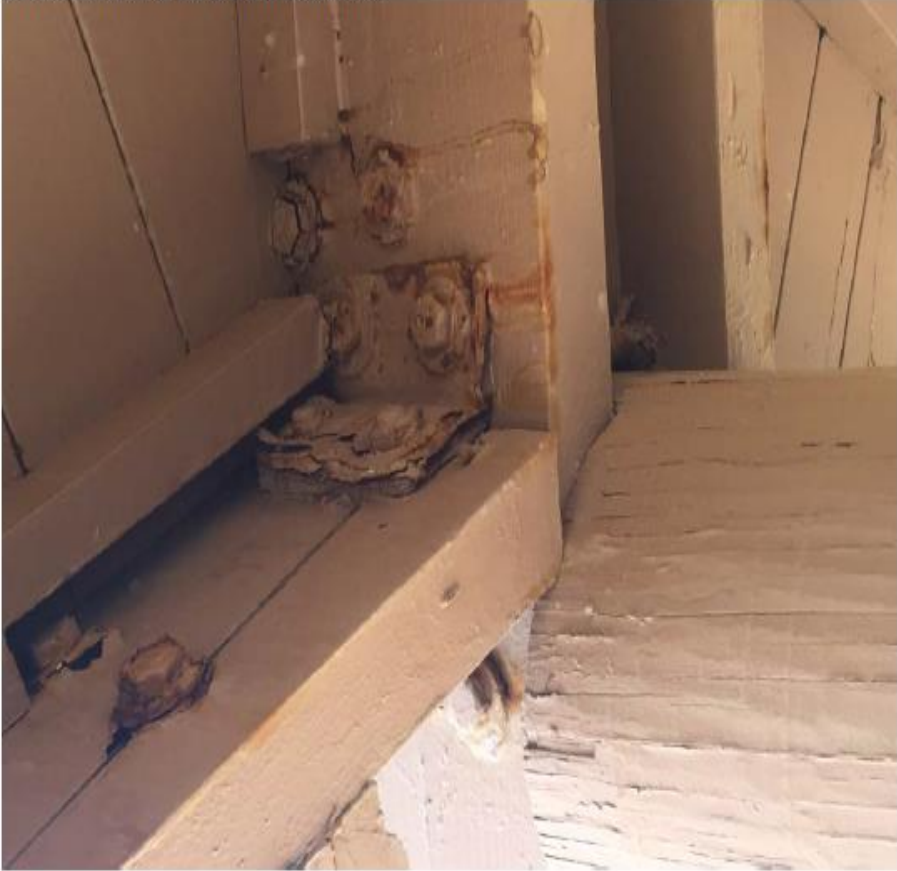
- o All exterior decks are severely decayed; they are unsafe and shall be removed.

- o Cantilevered beams are extremely impacted by decay and must be removed. Fortunately, the damage has reached only small portions of the interior walls yet, the points where the cantilever beams were resting are the most severely affected

Decayed Deck members and connectors

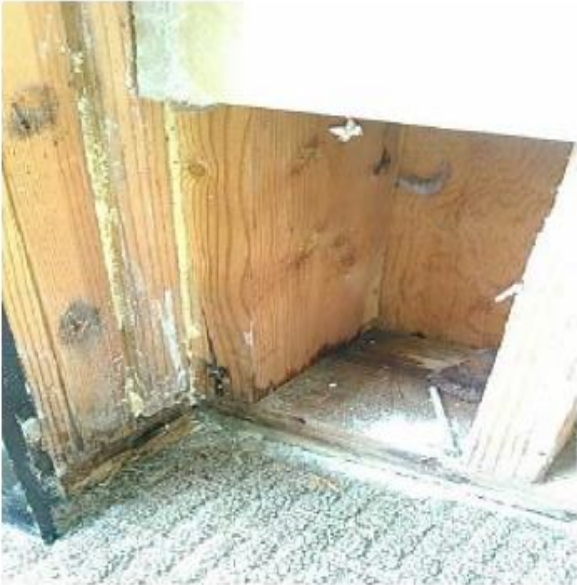
Damage at exterior walls

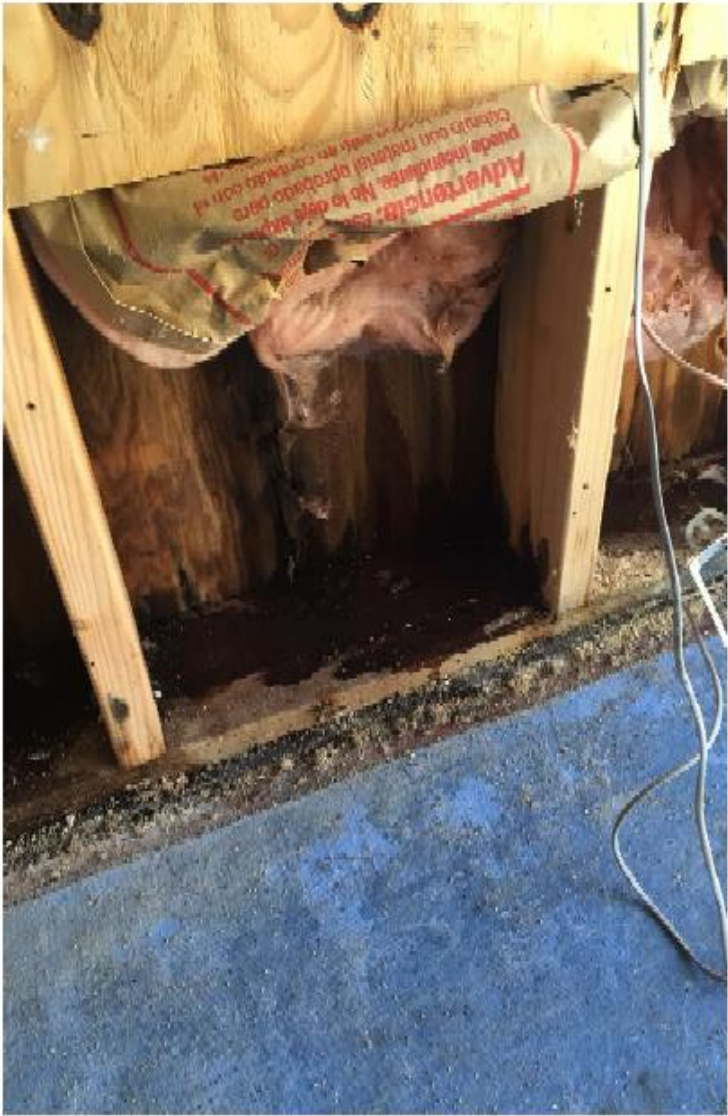
Exterior wall water infiltration

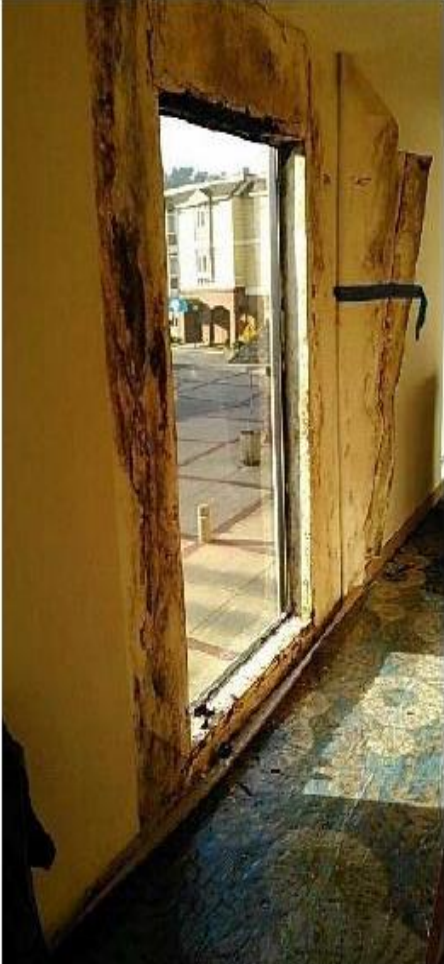
Mold and Decay around windows

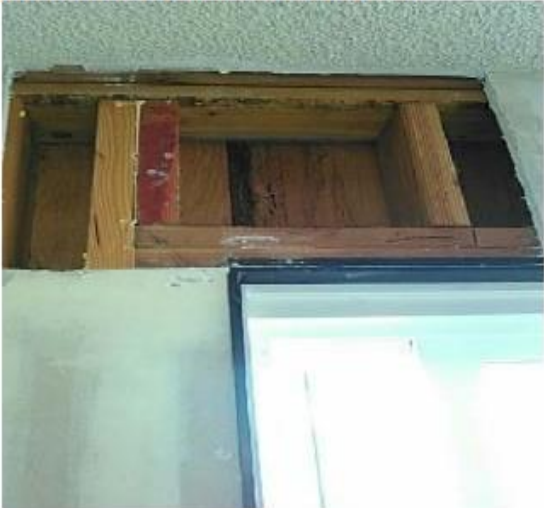
Windows installed without headers above

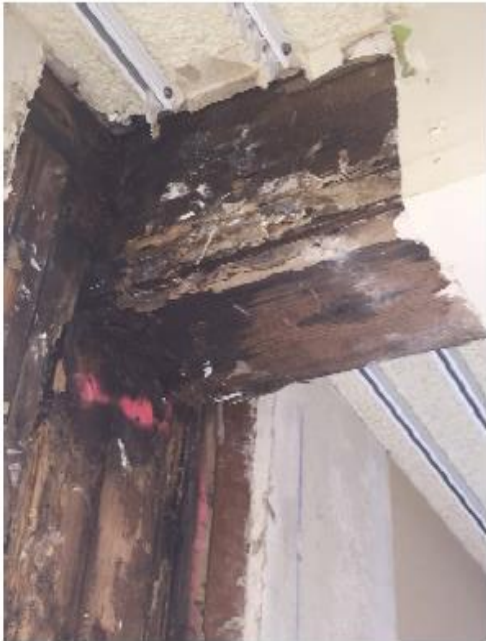
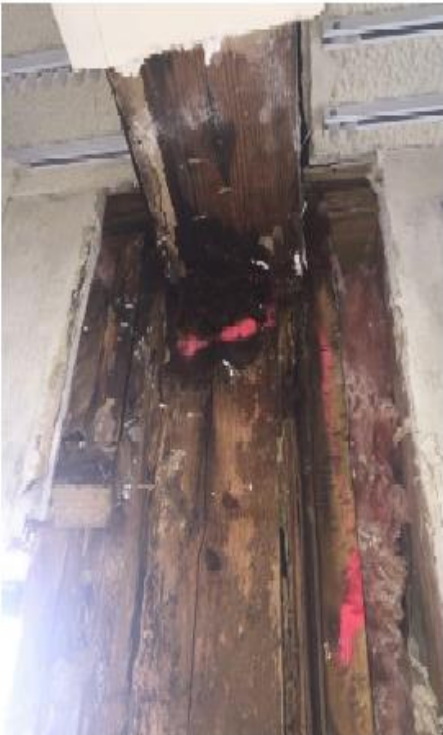
Damage at post and /beam connections at exterior walls

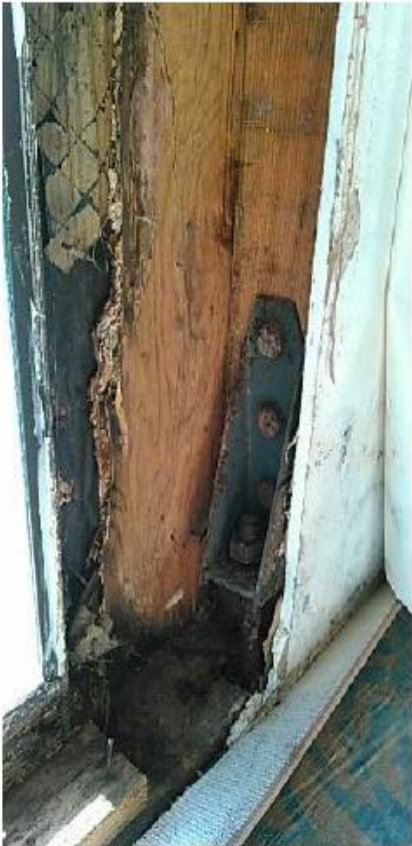
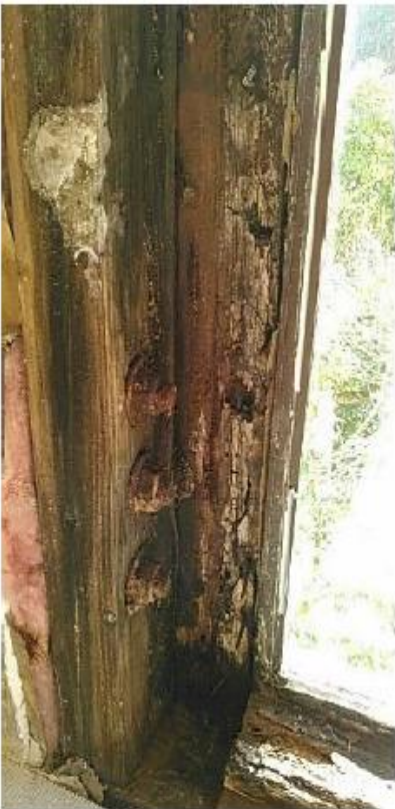
Shear wall damage

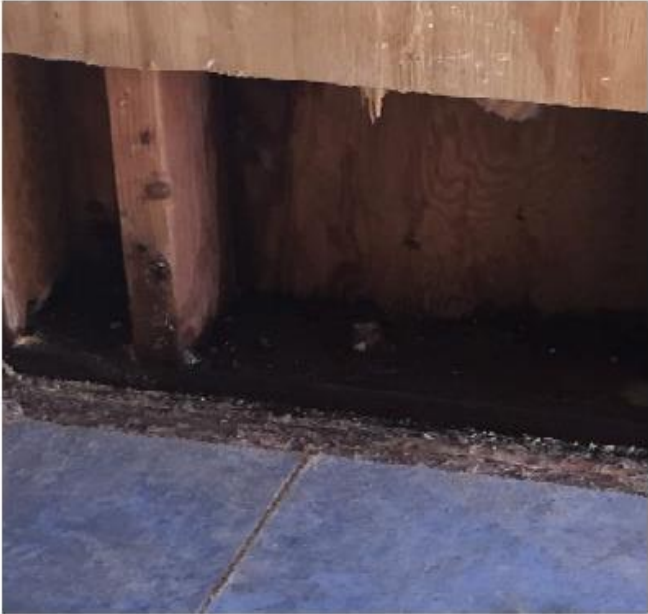
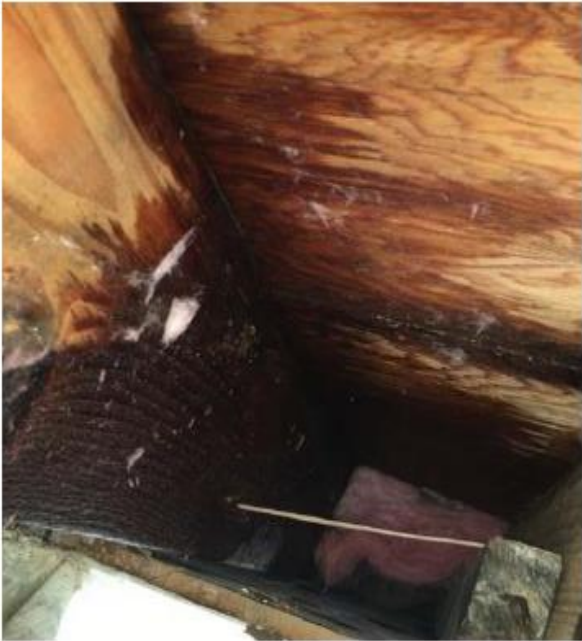
Saturation of wood at exterior wall

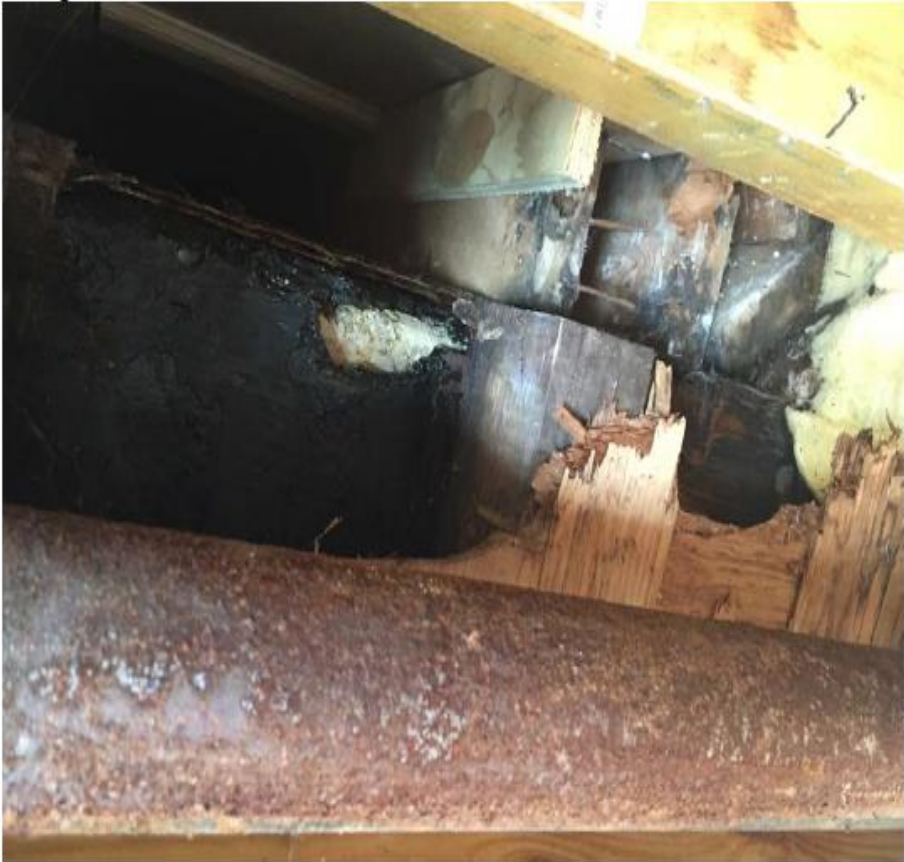
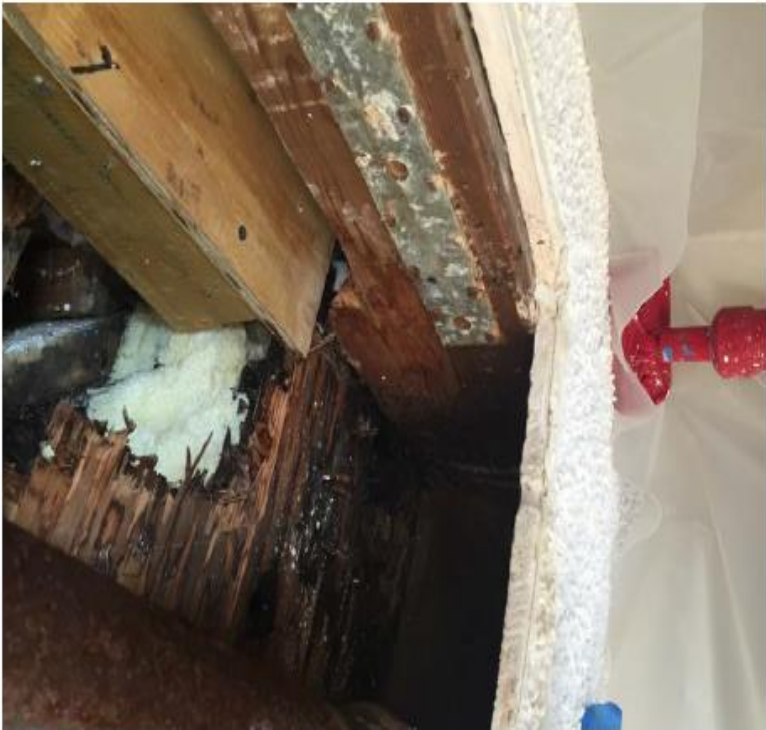
Damage below roof deck

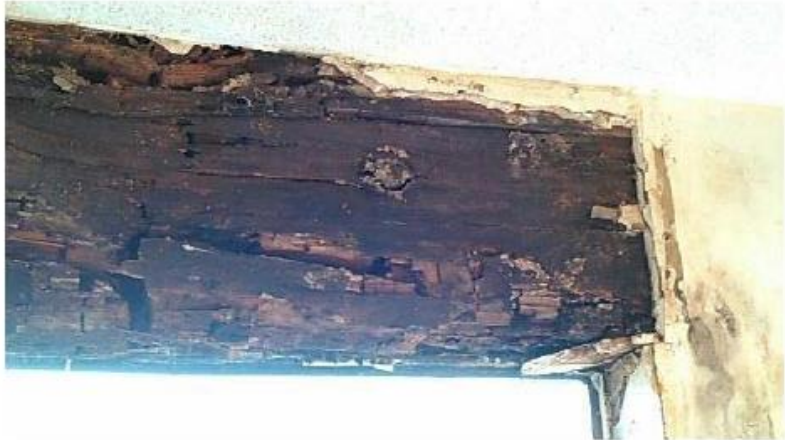
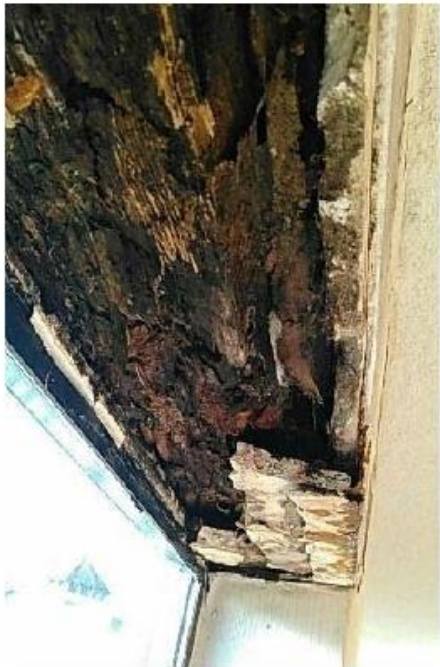
Window Header decay
